Department of Public Works

Emergency Catch Basin Cleaning Project Performance Audit

December 12, 2019

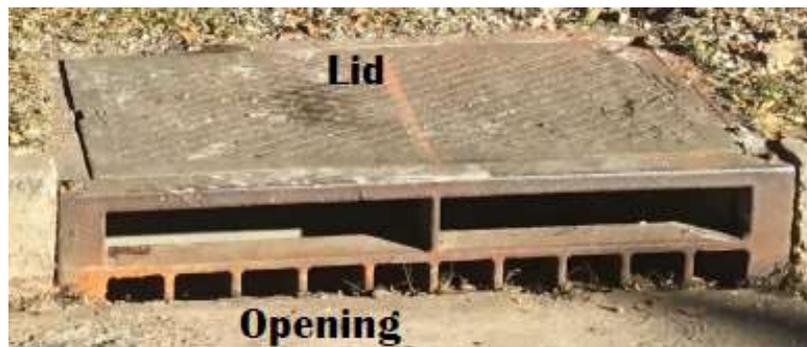
Figure 2: Catch Basin Lid and Opening

The sub-surface drainage system consists of multiple components, including catch basins. Catch basins are located below street level and allow water to flow through an opening at street level. The opening should have a covering that prevents debris from entering the catch basin. Refer to Figure 2 for a picture of a catch basin lid and opening. Once the water enters the catch basin through the opening, it flows through a smaller pipe, known as a lateral pipe, and then through a larger drainage collection line. Refer to Figure 3 for a picture of a catch basin lateral pipe.
